Department of Civil and
Environmental Engineering
Faculty of Engineering

Reference: Report – Flexural Testing of Bollards

Three types of bollards proposed by Sureguard Security Systems (Sureguard) were tested in the Structures Laboratory at the University of Waterloo on April 16, 17 and 20, 2009. The following reports the testing procedure and detailed test results. A brief analysis of the findings is also included.

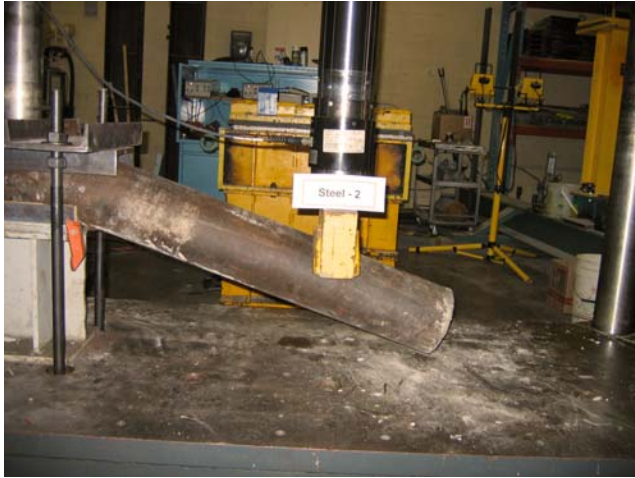
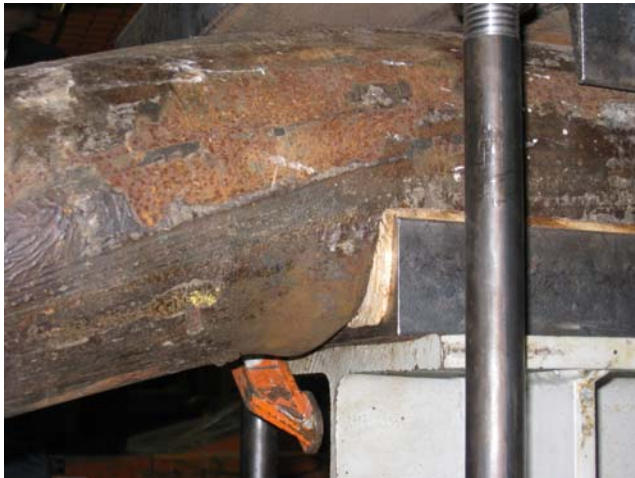
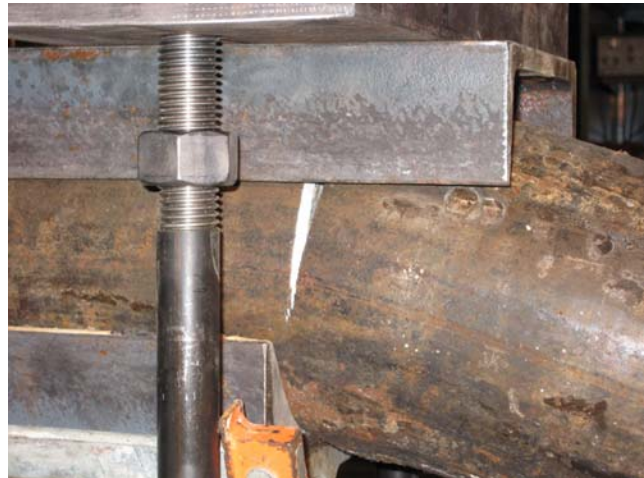
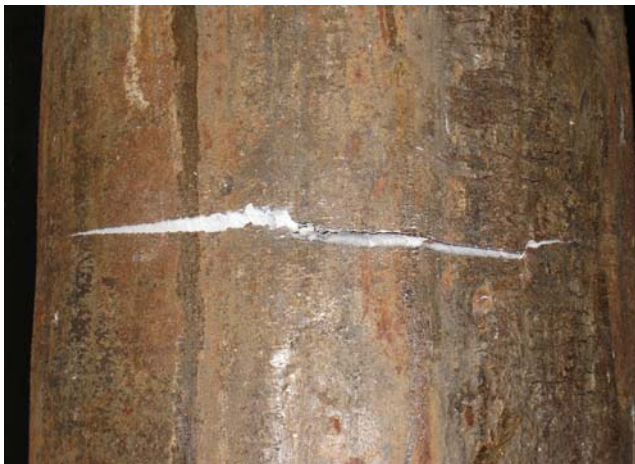
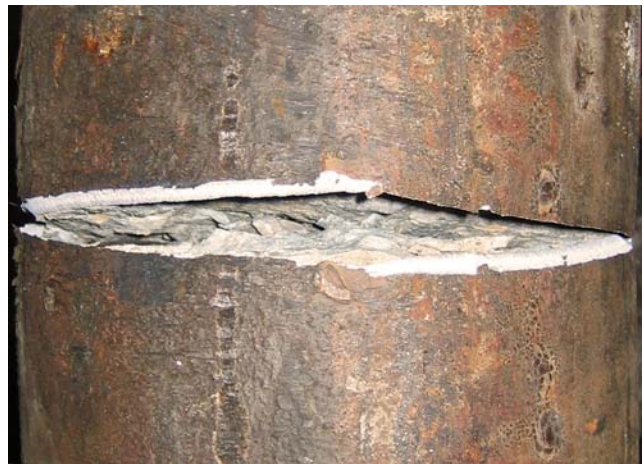
Figure 4 – Typical Steel Bollard Condition at Failure

For the steel bollards, a significant reduction in load carrying capacity coincided with rupturing of the steel pipe on the tension side (top) of the bollard. Prior to failure, distortion and “bulging” of the compression side was noted, suggesting damage of the confined concrete core had occurred. The typical condition of the steel bollard at failure is shown in Figure 4. The steel bollard specimen tested at a higher load rate (Steel-3) displayed a very large crack/rupture, indicating that the ductility of the steel is strain-rate dependent (see Figure 4).

Failure Condition – Slow Load Rate

Failure Condition – Faster Load Rate

Distortion and Bulging of Pipe – Slow Load Rate

Pipe Rupture and Bulging – Faster Load Rate

Pipe Rupture on Tension Surface – Slow Load Rate

Pipe Rupture on Tension Surface – Faster Load Rate

All nine (9) bollard specimens failed at the “base” of the bollard (adjacent to the fixed length). The failure conditions for the steel and plastic bollards are shown in Figure 4 and Figure 5, respectively.

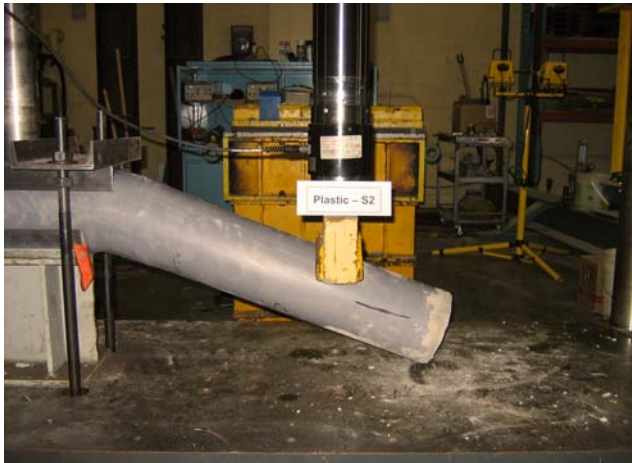
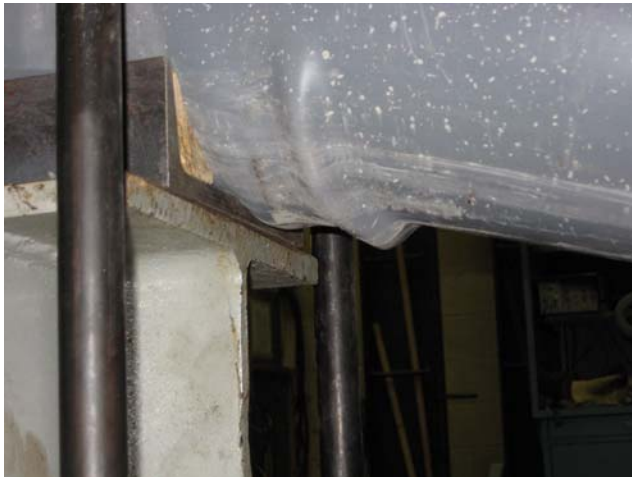
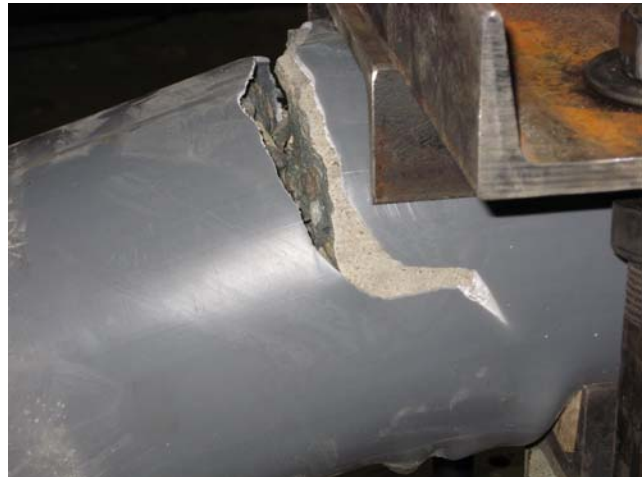
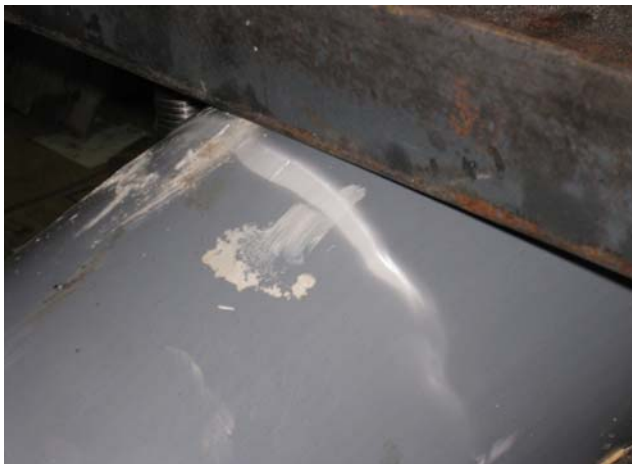
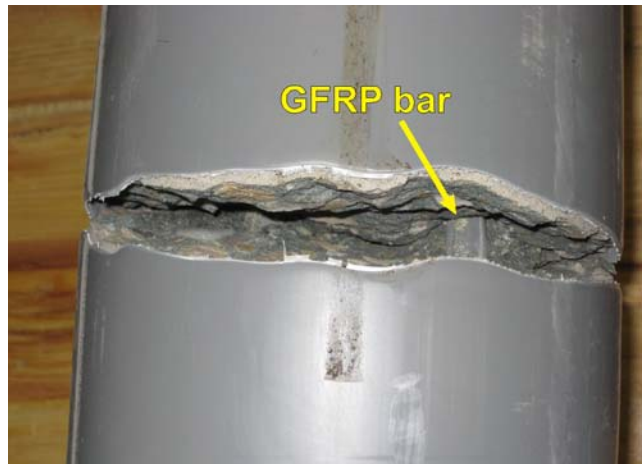
Figure 5 – Typical Plastic Bollard Condition at Failure

Failure Condition – Slow Load Rate

Failure Condition – Faster Load Rate

Distortion and Bulging of Pipe – Slow Load Rate

Pipe Rupture and Bulging – Faster Load Rate

Pipe Yielding on Tension Surface – Slow Load Rate

Pipe Rupture on Tension Surface – Faster Load Rate

The failure condition of the plastic pipe bollards was independent of the internal reinforcement type. A reduction in load carrying capacity coincided with distortion and bulging of the pipe on the compression side. For specimens tested at the lower load rate (Plastic-S1, Plastic-S2, Plastic-G1 and Plastic-G2), the plastic pipe did not rupture. However, “yield lines” were clearly visible on the tension surface of the plastic pipe. The typical condition of the plastic bollards at failure is shown in Figure 5. The two specimens tested at the higher load rate (Plastic-S3 and Plastic-G3) developed a large rupture of the plastic pipe on the tension side at the critical section, indicating that the ductility of the plastic is strain-rate dependent. In both cases, a large concrete crack coincided with the rupture in the pipe. The internal reinforcement, visible through the crack, was not ruptured at failure (see Figure 5).

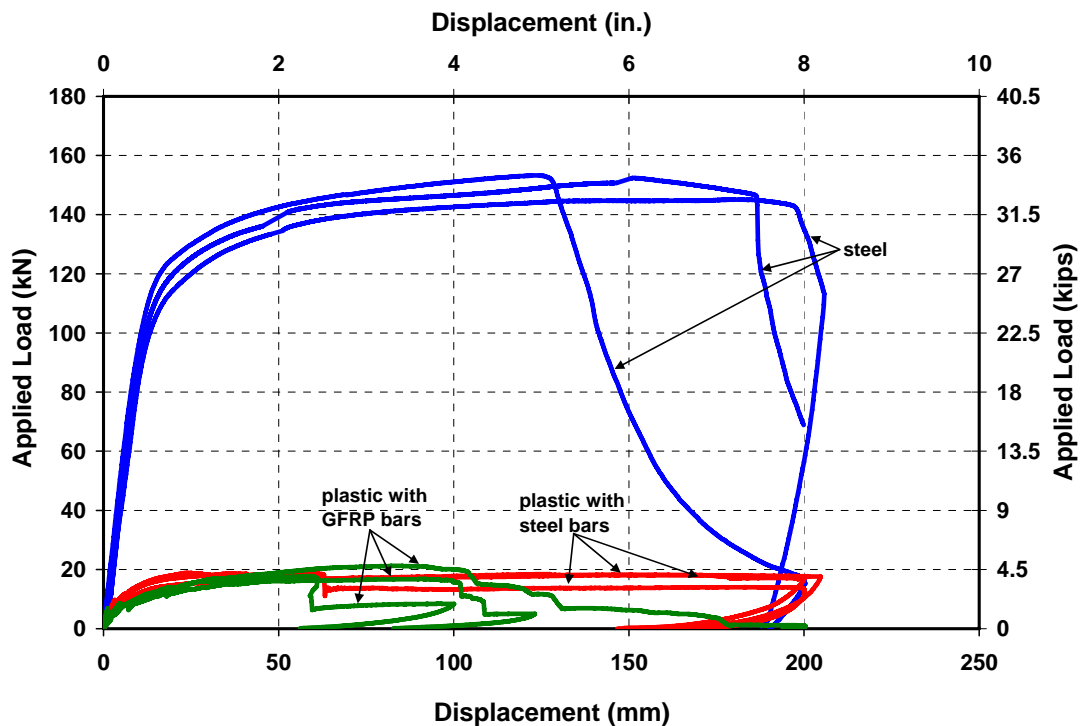
Figure 6 – Load-Displacement Data: All Specimens

The measured load-displacement behaviour for all bollards is shown in Figure 6. The same data are re-plotted for the steel and plastic pipe specimens in Figure 7 and Figure 8, respectively. The load data are the measured load (force) applied by the hydraulic actuator at a distance of 600 mm from the fixed length of the bollard (see Figure 2). The displacement data are the measured actuator stroke, which also corresponds to the lateral displacement of the bollard at a distance of 600 mm from the fixed length of the bollard base. Since the displacement values are based on the actuator stroke, they include a small displacement component due to deformation of the test frame and fixtures. However, this deformation component is very small in comparison to the deformation of the test specimen, and can be neglected for the purposes of this discussion.

The displacement recovered upon unloading was pronounced for the plastic bollards, as visible in Figure 6 and reported in Table 2. The data show that the plastic bollards were able to recover approximately 40 to 50 mm (up to 2 in.) upon unloading, even after considerable inelastic deformation and damage had occurred in the form of concrete cracking and plastic pipe yielding or rupture. In contrast, the displacement recovery for the steel bollard was less than 20 mm (~3/4 in.). This difference in behaviour is attributed to the fact that the steel pipe ruptured in

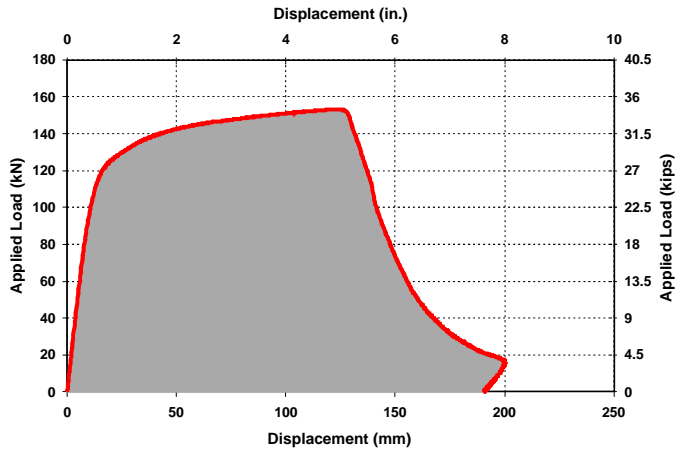
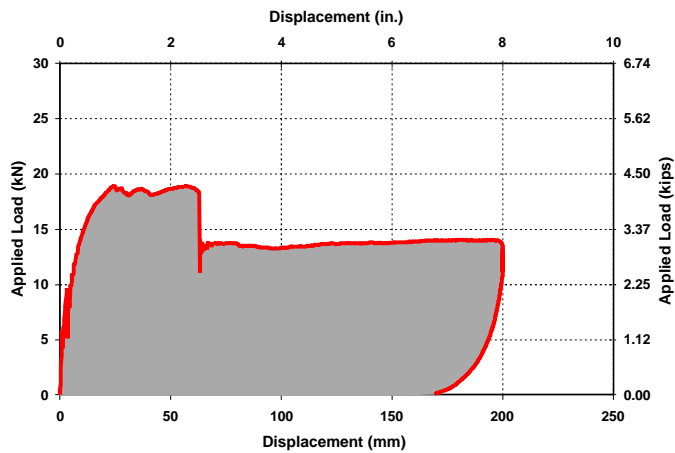
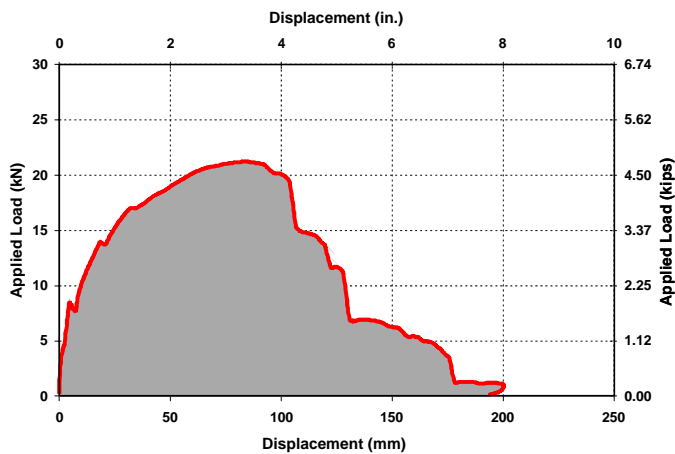
Figure 9 – Energy Dissipation for Bollards Tested Under Rapid Load Rate

The energy dissipated by each of the three bollard types was computed using the load-displacement response for the bollards tested under the rapid load rate (50 mm per sec.). The results are shown in Figure 9, where the energy dissipated is represented by the shaded area under each of the curves. All three of the tests under the rapid load rate were continued until an imposed displacement of 200 mm was reached. The full load-displacement curve up to the 200 mm displacement, and including the unloading portion of the curve, was considered when computing the energy dissipation.

Energy Dissipation
 (shaded area under curve)
 = 21,570 J

Steel Bollard

Energy Dissipation
 (shaded area under curve)
 = 2,850 J

Plastic Bollard with Steel Reinforcement

Energy Dissipation
 (shaded area under curve)
 = 2,460 J

Plastic Bollard with GFRP Reinforcement

The energy dissipated by the two plastic pipe bollards was approximately equal, with the steel-reinforced bollard dissipating slightly more energy than the GFRP-reinforced bollard. The steel pipe bollard dissipated approximately 8 times more energy than the plastic bollards due to its substantially greater strength.

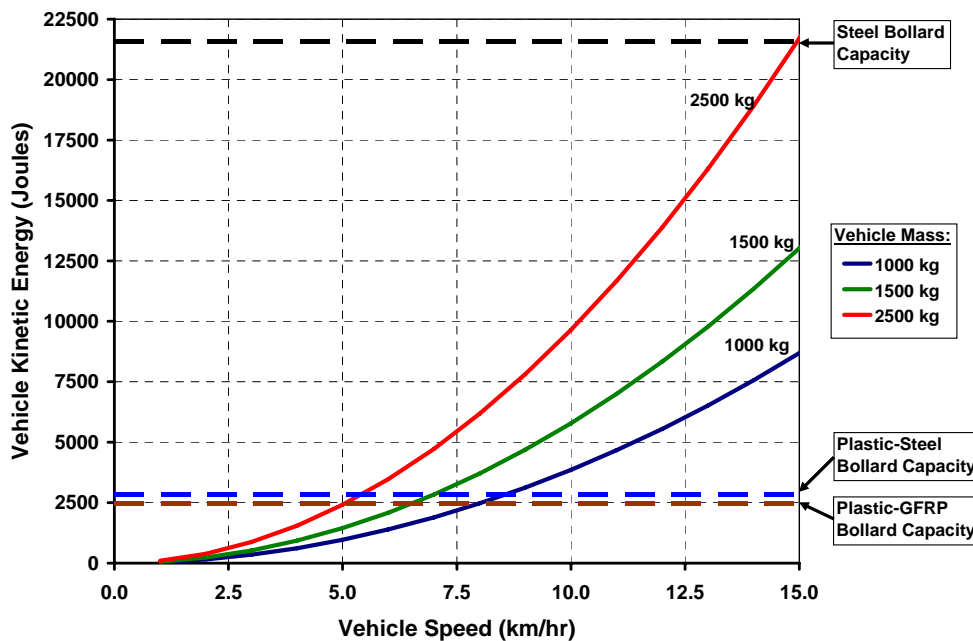
Figure 10 – Vehicle Kinetic Energy as a Function of Vehicle Speed

The kinetic energy of a moving vehicle was computed for three vehicle sizes and vehicle velocities up to 15 km/hr (see Figure 10). A 1000 kg vehicle represents a compact car, a 1500 kg vehicle is typical of a mid-size car, while a 2500 kg vehicle represents a light truck. The energy dissipation capacities of the three bollard types are indicated in Figure 10 as horizontal lines.

The data plotted in Figure 10 indicate that the energy dissipation capacities of the plastic bollards (approx. 2500 J) are comparable with the kinetic energy of a 2500 kg vehicle moving at 5 km/hr, or a 1000 kg vehicle moving at approximately 7.5 km/hr.

It is important to note that the data plotted in Figure 10 and the related discussion can not be used to determine the impact resistance of the bollards, nor can they be used to suggest application or safe-use limits for the bollards. A vehicle impact test utilizing the actual installation conditions for the bollards must be conducted to determine the vehicle impact limits for the bollards.
